***PROGRESS REPORT
OF
LMTV FLYWHEEL HOUSING
AND
DRIVELINE
FAILURE INVESTIGATION***

Contract No. DAAE07-98-C-M012

***Hayes Hobolth
17 August 1998***

Subject: Summary statement of root cause of Flywheel housing and driveshaft failures
LMTV

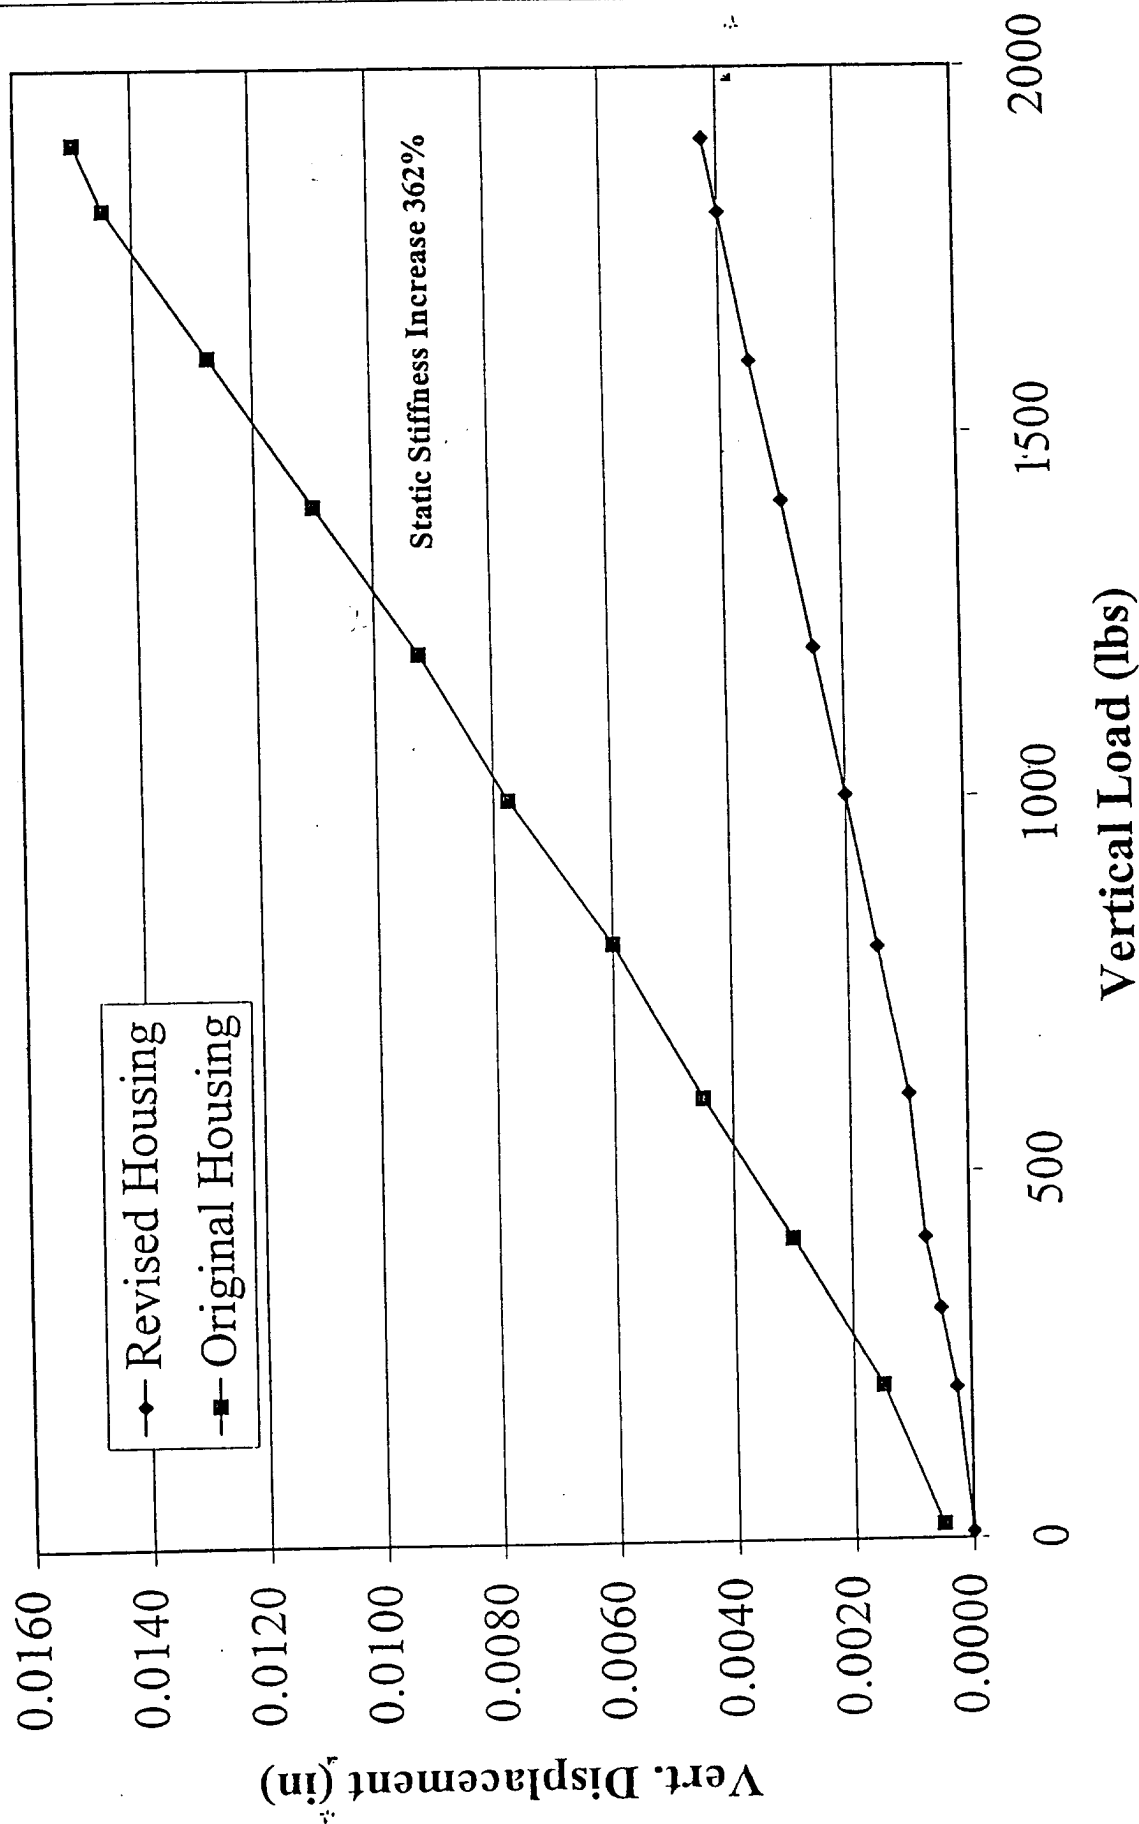
Axial Deflection at Bottom of Hsg For Original and Revised Housings vs. Vertical Load

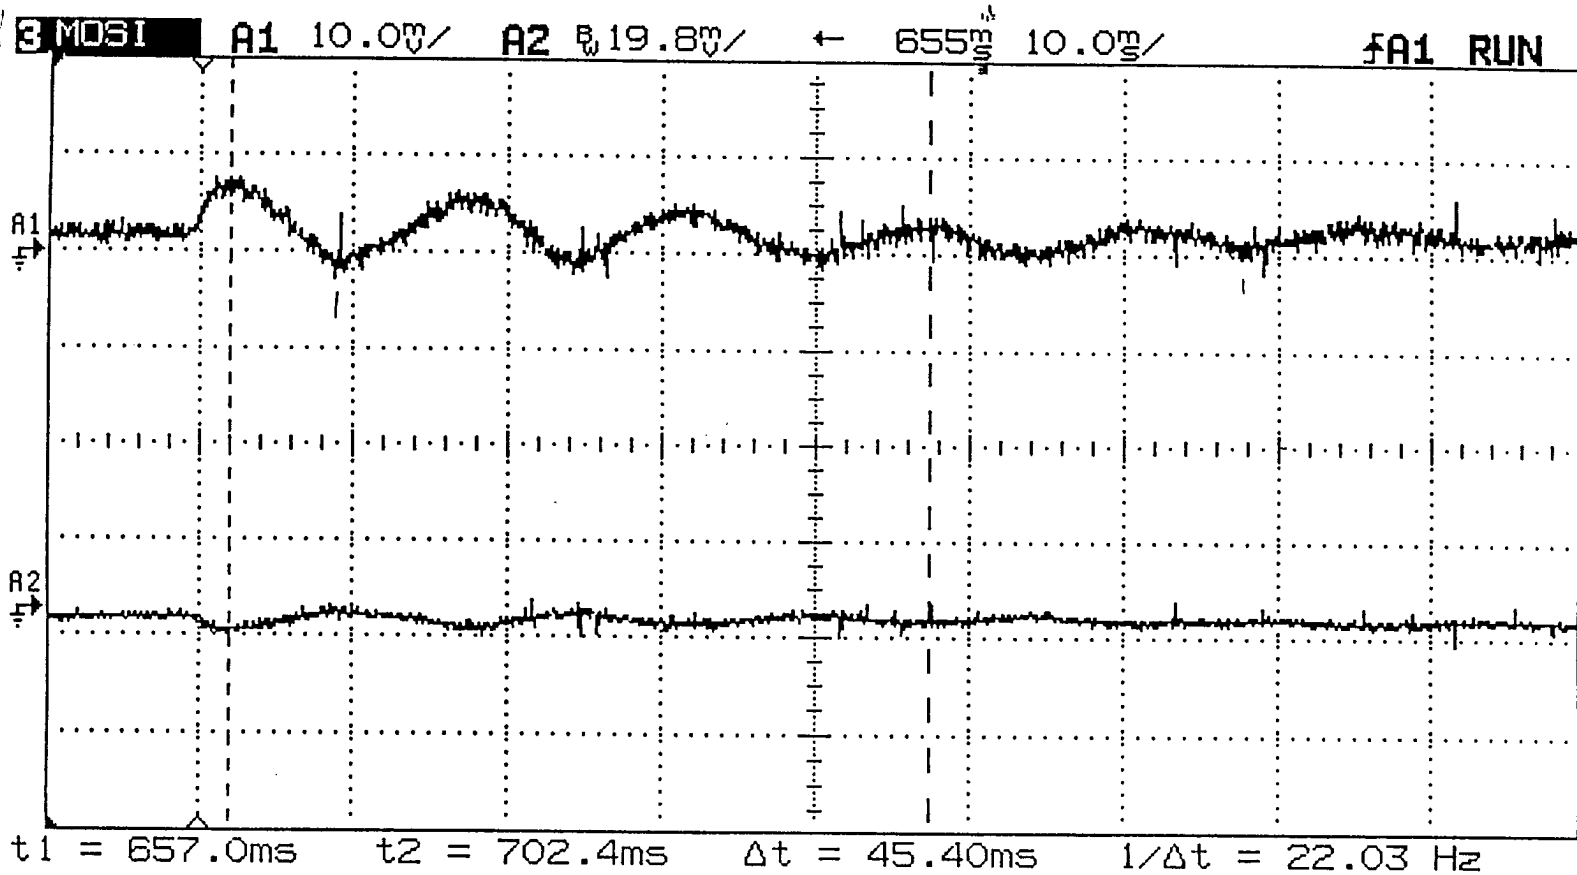
Impact Test of Natural Frequency 65-68 Hz (Original - 47.6 Hz)

Preliminary Results of First Mode Vertical Bending

- Impact test agrees with Caterpillar projection for ductile iron and increased section.
- Speed sweeps do not show a clearly defined resonance.
- Probing for the characteristic first mode vertical bending suggest that the new bending mode may be critically damped

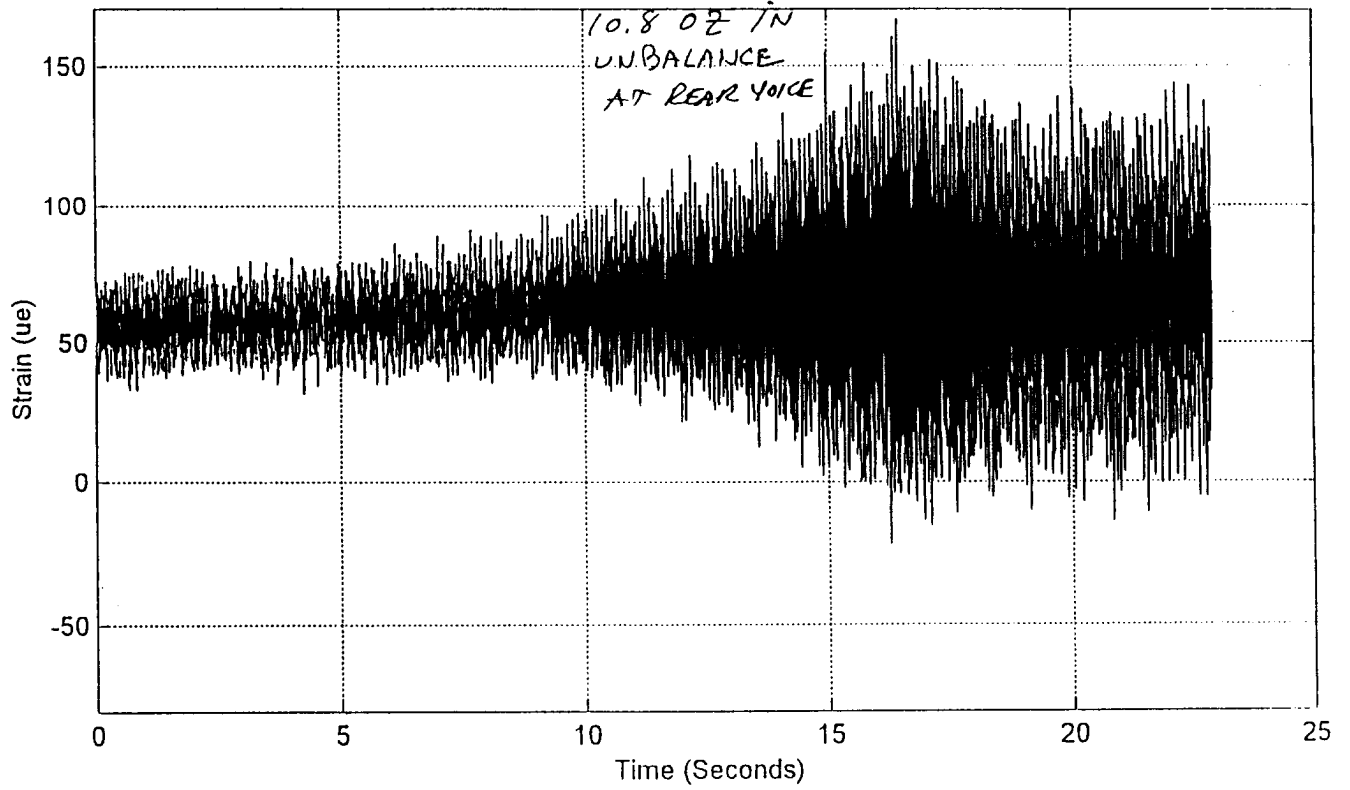
Dfmtv2k.004 7/10/98
Upper Left Strain vs. Time

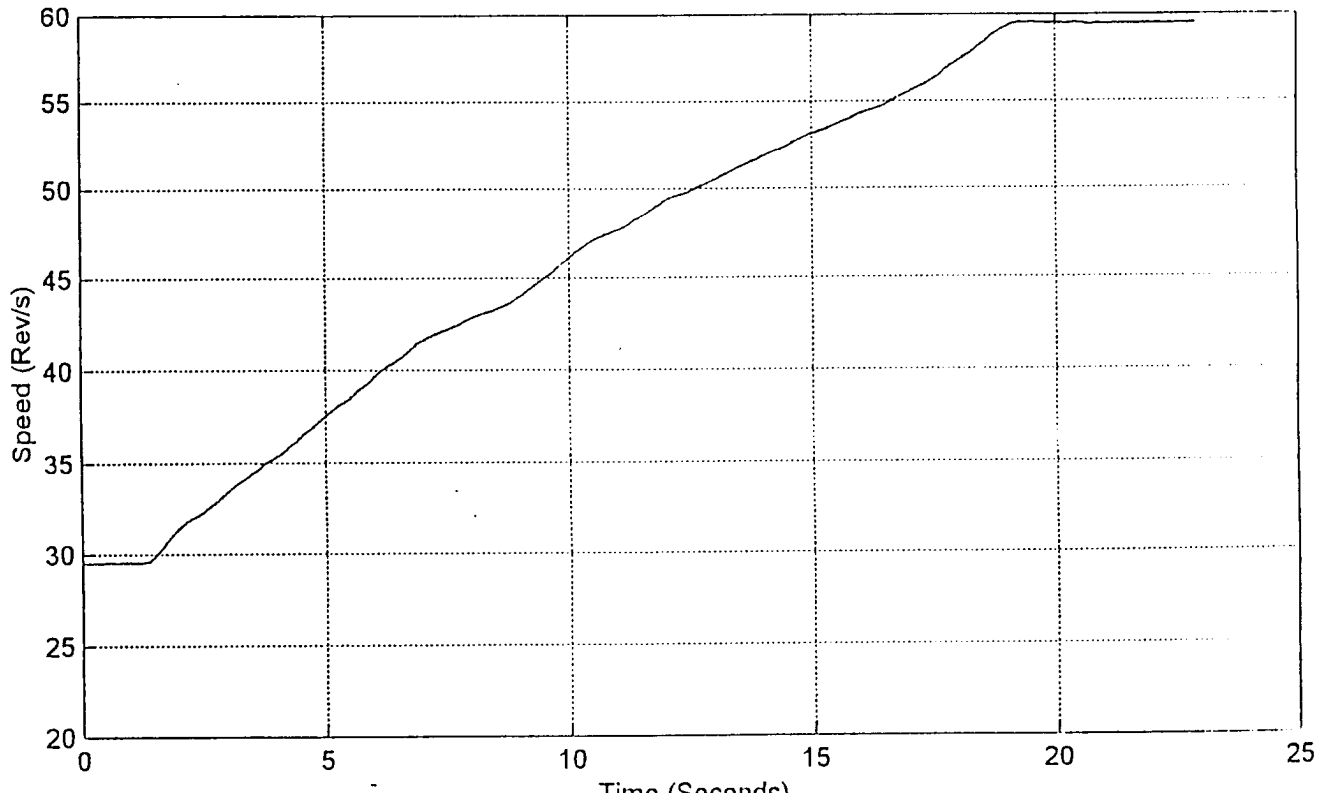
Rear Shaft Speed vs. Time

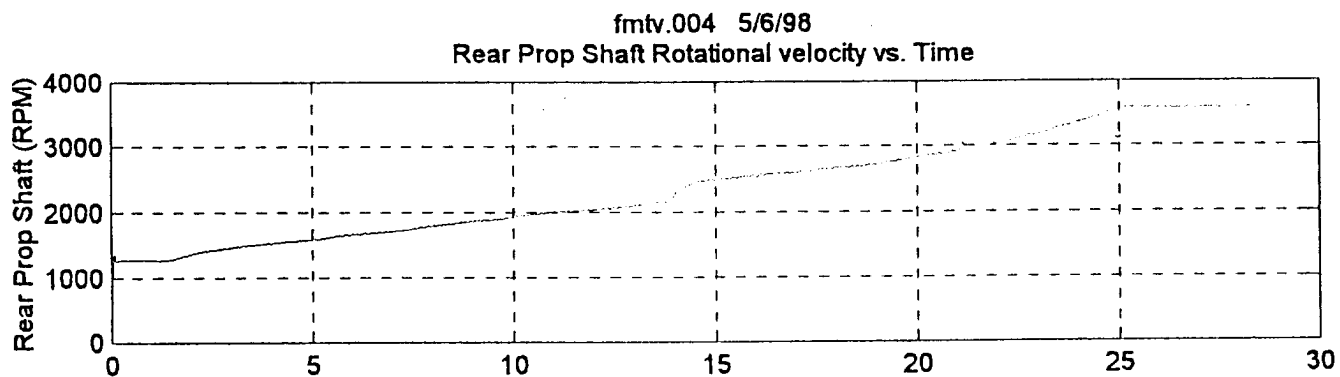
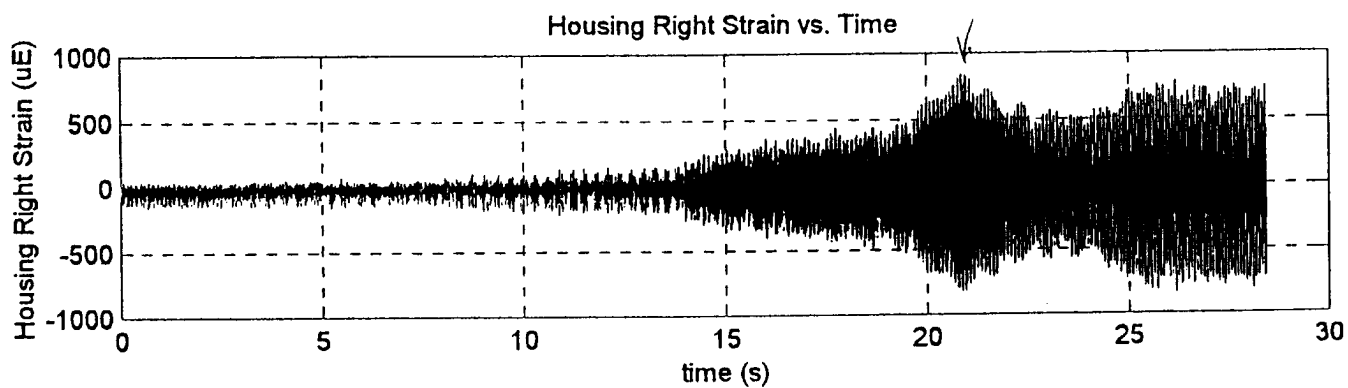
10.8 OZ IN UNBALANCE AT
REAR YOKE

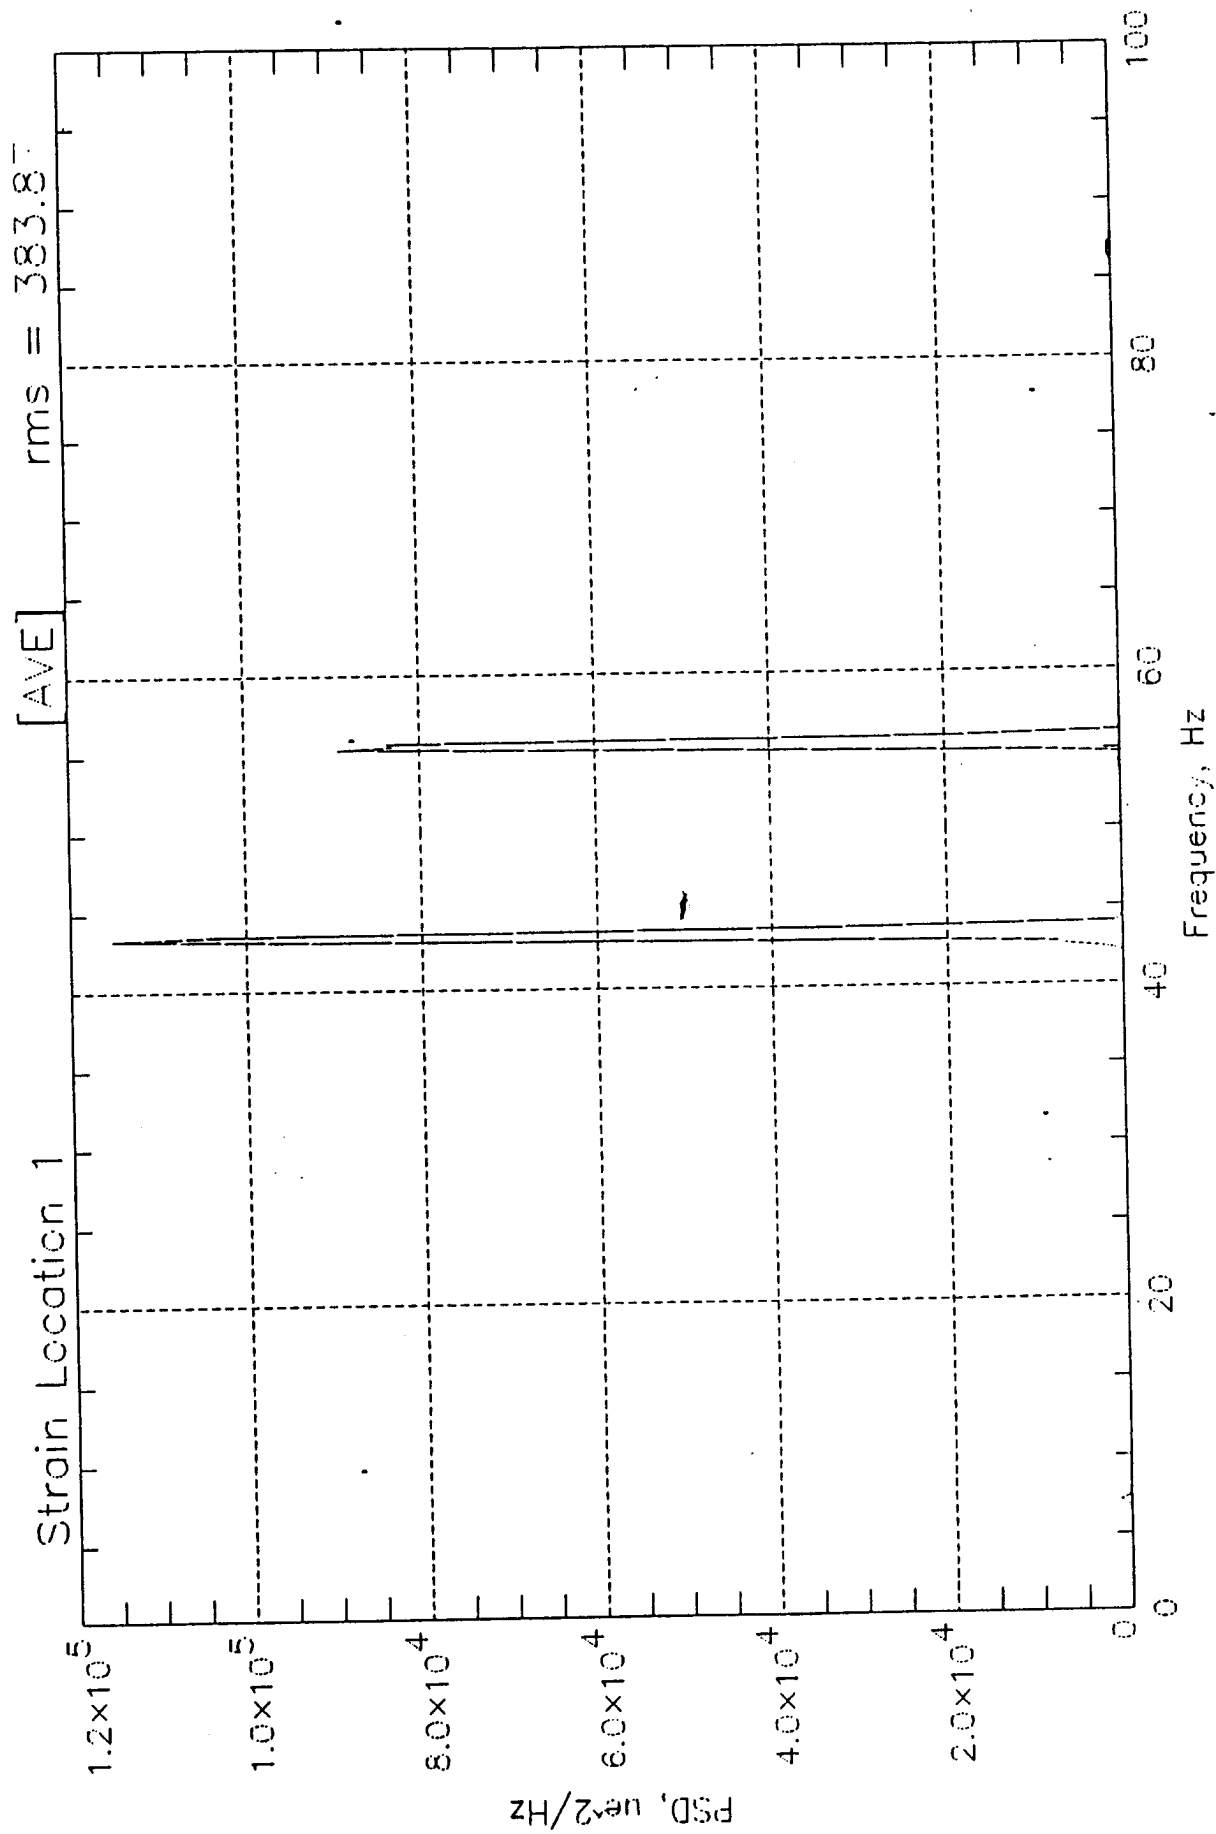
RUN 309: Paved, max mph, engine fan on, loaded
FMTV Bell Crank Housing
6 Averages; Delta f = 0.20 Hz; Block size = 2048; Hanning Window Enabled

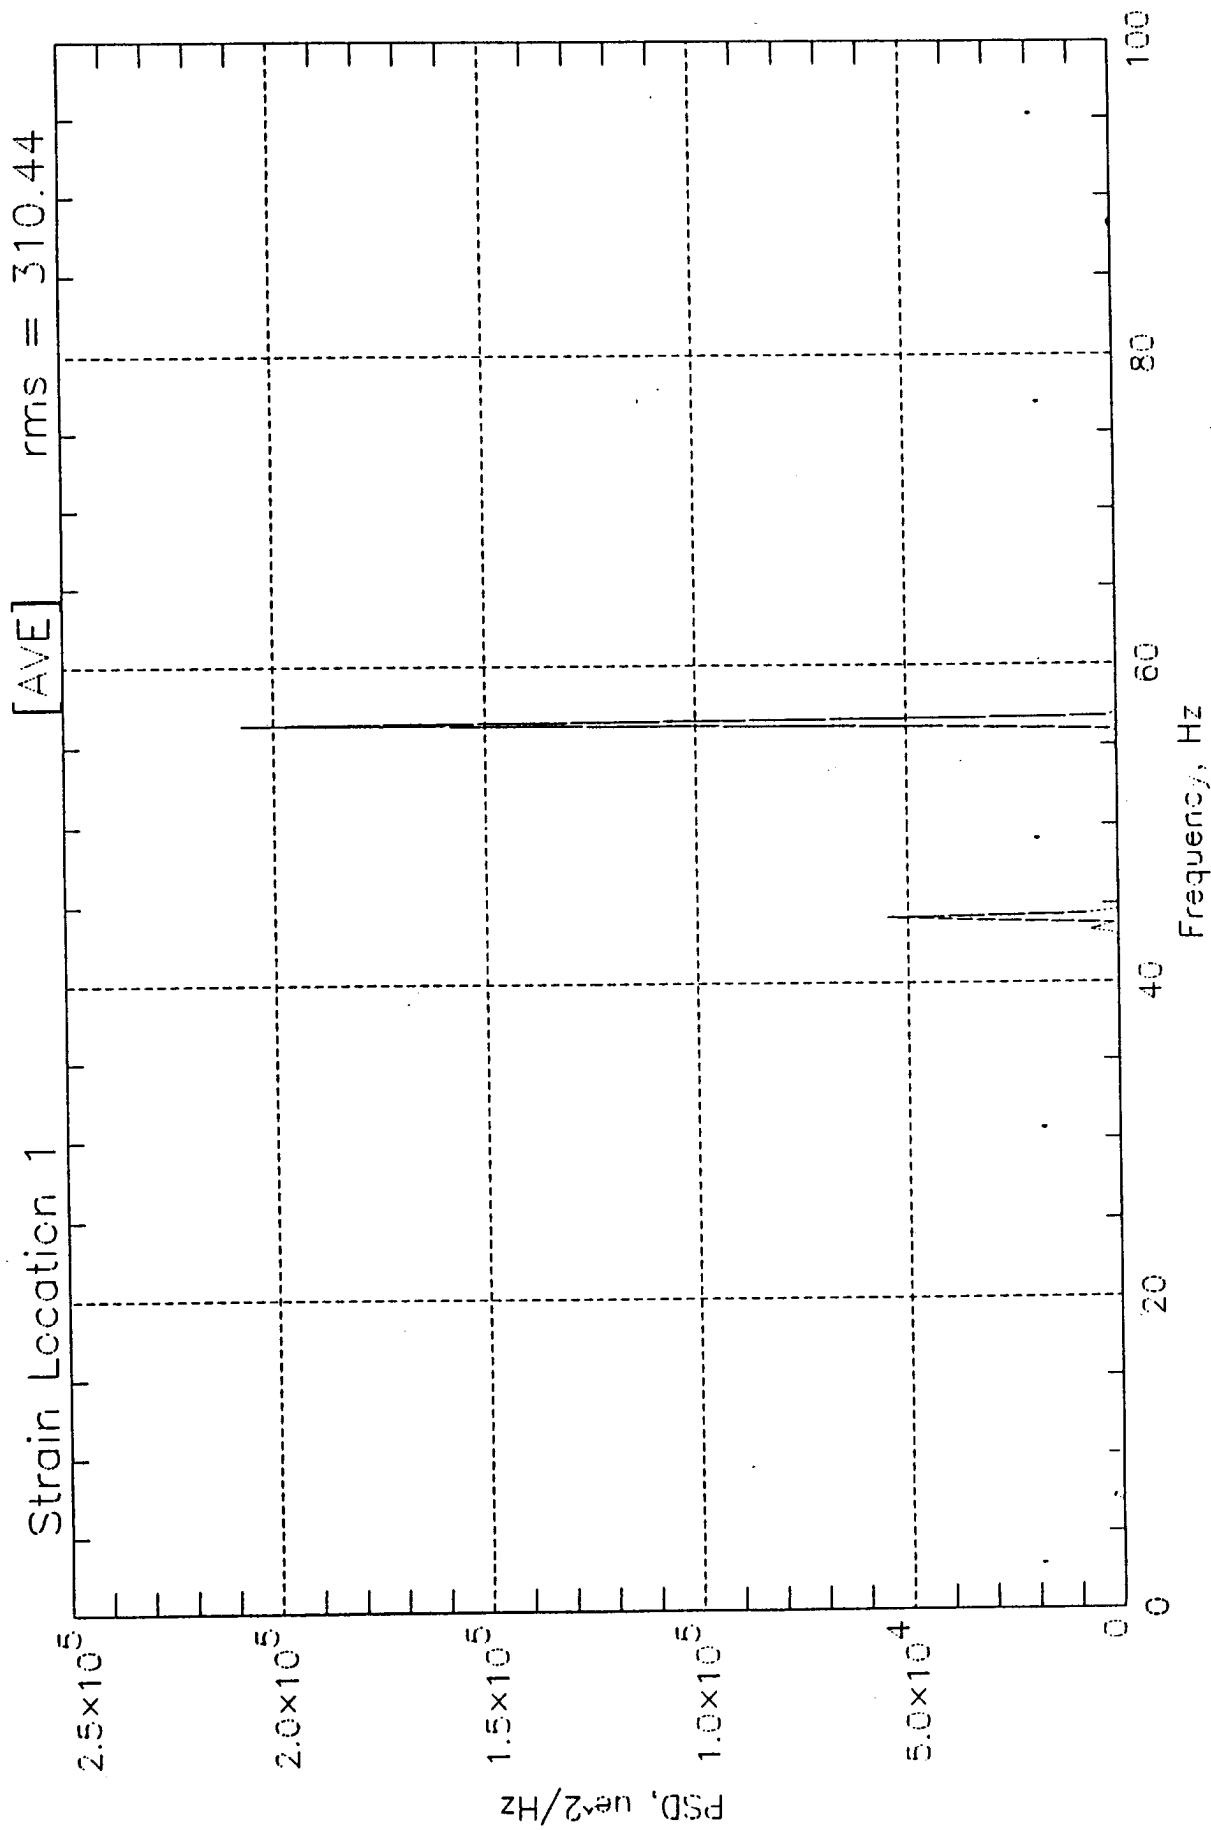
RUN 303: Paved, max mph, engine fan off, loaded
FMTV Bell Crank Housing
6 Averages; Delta f = 0.20 Hz; Block size = 2048; Hanning Window Enabled

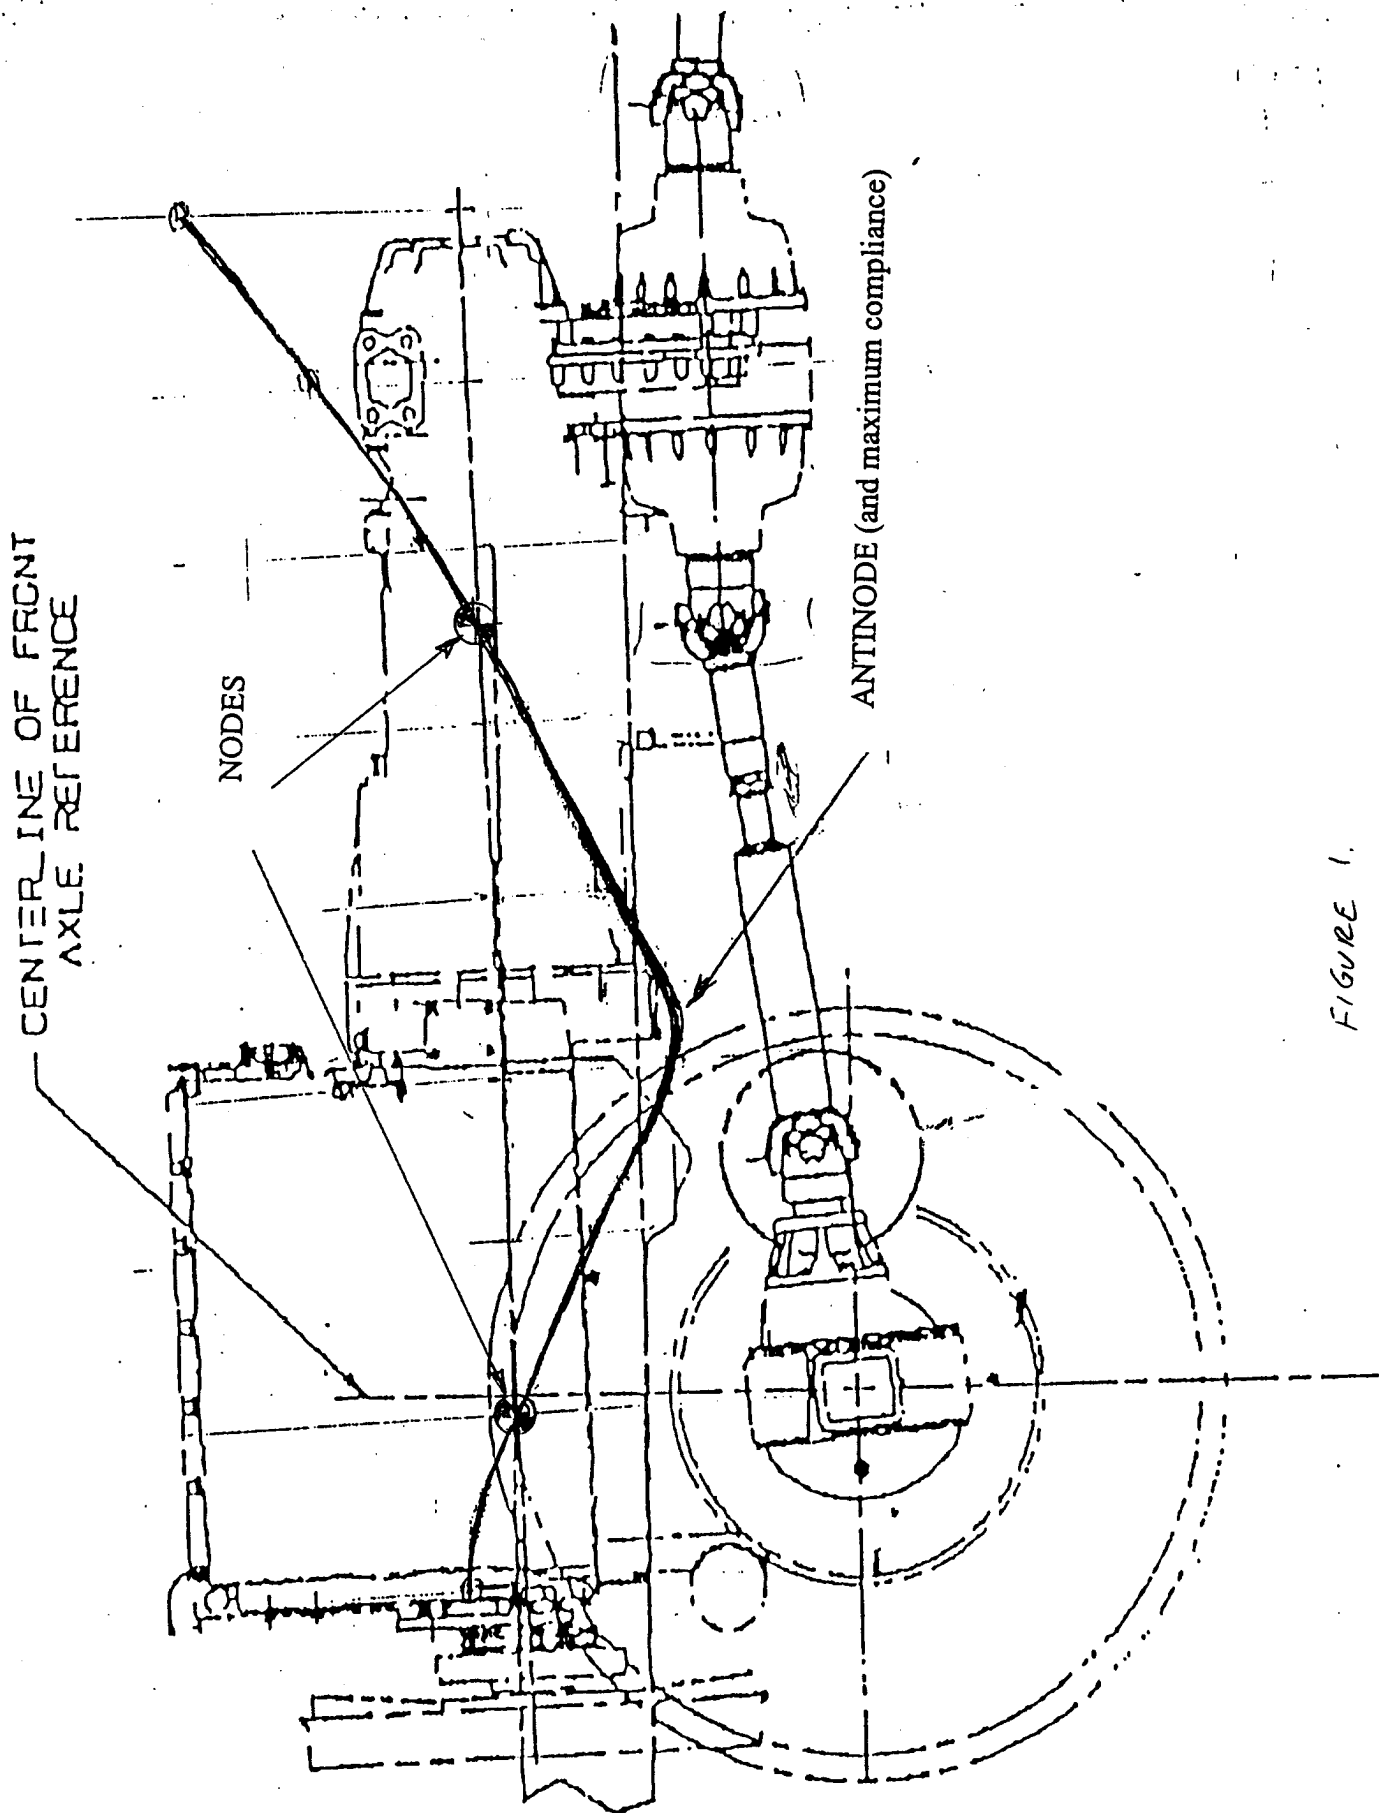
FIGURE 1.

An important relationship is shown in Figure 1, which is a mode shape of the vertical bending mode of the resonant response at its peak excited by the an unbalance at the transfer case output. The dynamic first order vertical velocity was probed at 10 inch increments along the length of the powertrain and is plotted on a side view. It clearly shows that the elastic energy is stored in the deformation of the flywheel housing.

FIRST MODE VERTICAL BENDING @ 47.6 HZ
